Microstructural Analysis of the Brass Seat of a Valve from the 1907 Steam Tug "Hercules"

C.R. Brooks and D. Monday

The steam tug Hercules was an ocean-going and bay tug for 55 years before being retired. It is now being restored by the National Park Service (as of 1993 printing of this article). A broken steam valve was obtained for microstructural examination. The body was gray cast iron, and the stem and seat were brass. The examination centered on corrosion of the brass components. The seat and shaft were α brass, with a hardness of 64 and 79 DPH, respectively. A nut held the shaft onto the seat and was α - β brass with a hardness of 197 DPH. Welded on the end of the shaft was a ring of hard (DPH 294) α - β brass, which seated against the nut. The brass seat and stem showed little corrosion. However, the α - β brass nut and welded tip show extensive dezincification. This process of removal of Zn and the retention of Cu began in the high Zn β phase, but eventually both phases were attacked. The depth of penetration was consistent with dezincification rates reported in the literature for such brasses in salt water if the valve had been in service about 55 years.

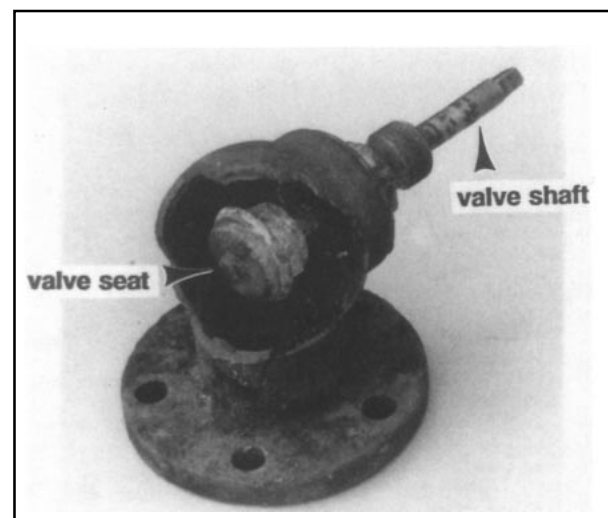
The Hercules is currently undergoing extensive restoration. This has required replacement of inoperable parts. We were able to obtain a broken gate valve for examination (Fig. 1). The outside was made of gray cast iron, and the outlet port was broken off. The valve shaft and seat were of brass, and it is this part that was examined microstructurally and its features are reported in this paper. Of particular interest are the regions of corrosion by dezincification.

Fig. 1 The broken tug boat valve in the as-received condition

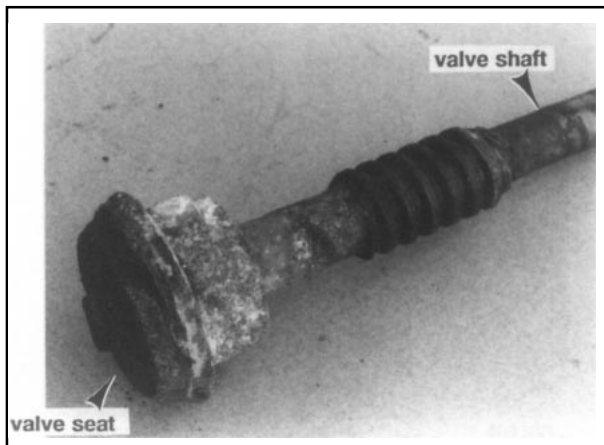
2). The seat and parts near it show extensive corrosion, but the stem outside the valve is relatively unaffected. The valve seat part was removed and mounted in epoxy, then cut in a plane through the shaft axis with a high-speed cut-off wheel using copious water for cooling.

Fig. 2 The valve seat and shaft assembly in the as-received condition

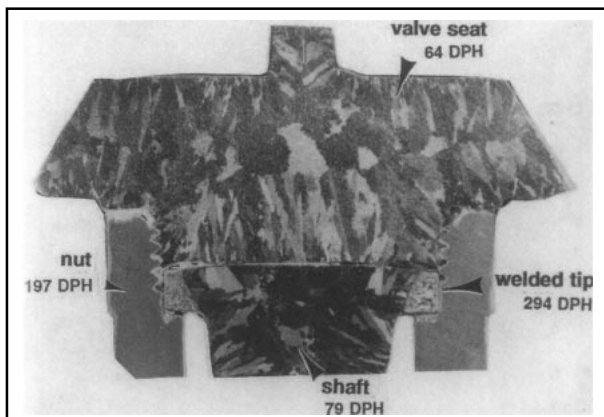
Figure 3 shows the cross-section of the valve. The columnar grain structure of the seat and shaft show that these were fabricated by casting. They had

similar hardnesses. Around the edge of the end of the shaft is a small ring with a different structure and which has a high hardness (294 DPH). This tip was the contact location for the nut. It does not contain columnar grains.

Figure 3 shows that the shaft is held onto the valve seat by the nut by contact with a tip having a

Fig. 3 Macrograph of the cross section through the assembly

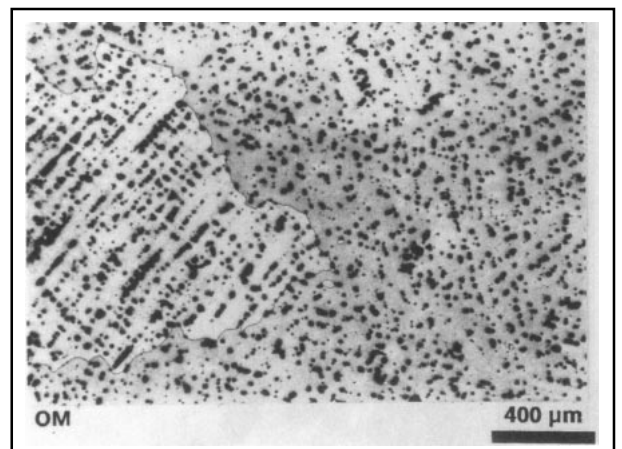
The microstructure of the shaft (Fig. 4) shows the large grains and dendritic structure of a casting. It has interdendritic porosity and is single phase; the valve seat had a similar structure. Optical observations showed that the two parts had a slightly different color, indicating a slightly different Zn content. The microstructure of the nut in Fig. 5 shows that it is in the wrought condition. It contains α and β , and lead particles are also present. These phases are discriminated by the EDS analysis (Fig. 5).

Fig. 4 Microstructure of the shaft

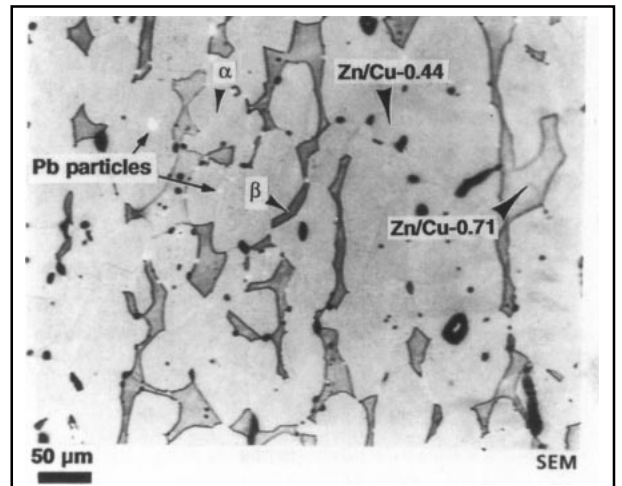
Fig. 5 Microstructure of the brass nut

The nut contained small (e.g., 1 μ m) Pb particles (Fig. 5), but in the corroded regions these were much larger (Fig. 9 and 10). It appears that during the solution of the β phase, the small Pb particles dissolved, then redeposited as larger particles. The Cr detected in the lead region of Fig. 10 could be from the etchant used. However, it may be that traces of the more noble Cr in brass were redeposited with the Pb.

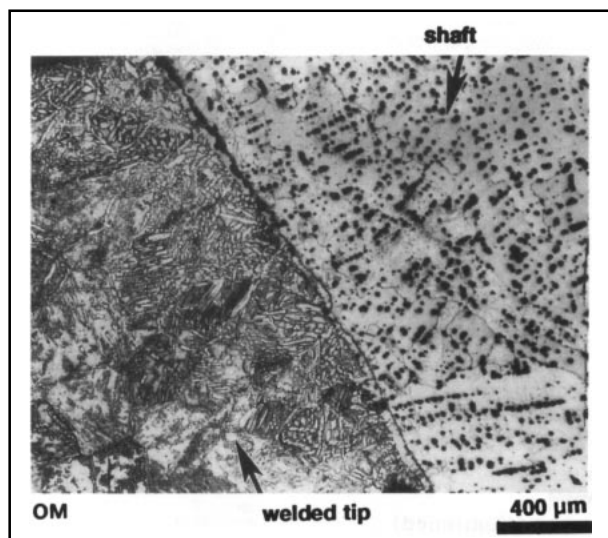
different macrostructure. The interface between these two regions is shown in Fig. 6. It appears that

Fig. 6 Microstructure of the interface between the valve seat and the welded tip

the tip (ring) was welded onto the end of the shaft. The microstructure of this welded tip is shown in Fig. 7. It also consists of α and β phases, with a small amount of Pb particles present.

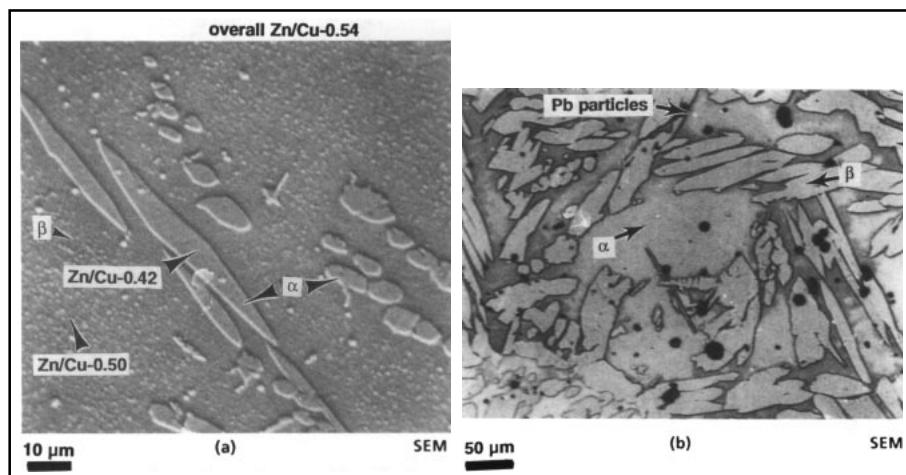
Fig. 7 Microstructure of the tip welded on the valve seat

rapid cooling from high temperature (Ref 7). It appears to be joined by welding. The higher hardness of this ring is associated with its finer structure (Ref 7). It may have been designed originally to serve as a hard region for contact with the nut, or it may have been added to repair a damaged region.

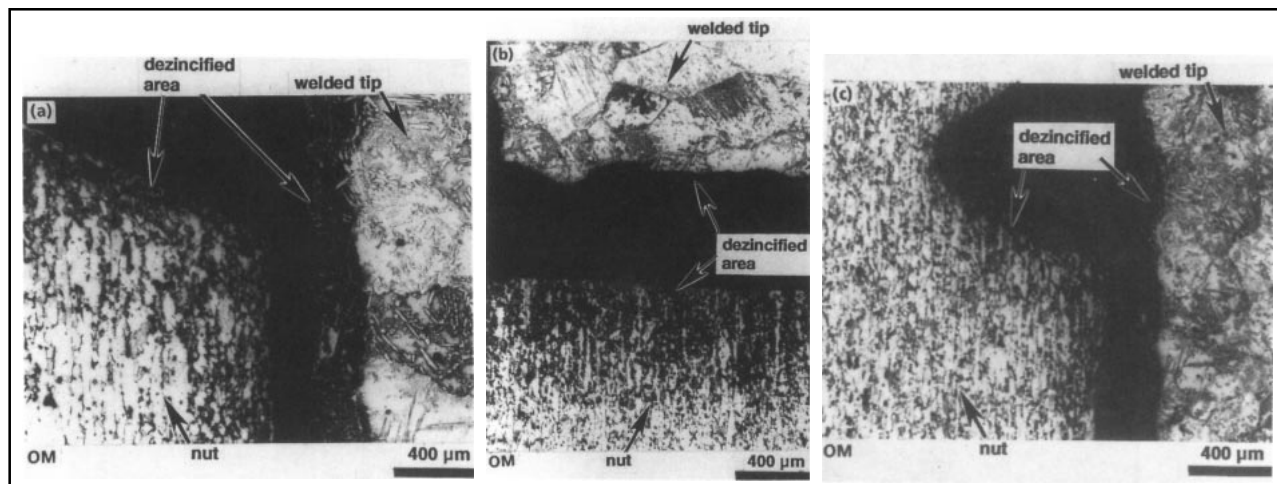
Fig. 8 Micrographs showing zinc-depleted corrosion regions

The cross-section optical microscopy clearly revealed regions along the surfaces that are Cu-colored. These are along both the external and internal surfaces of the nut and the welded tip. The microstructures of some of these regions are shown in Fig. 8. In these regions there is considerable porosity. Figure 9 shows a region of the nut at the surface in which Zn was almost nondetectable. Figure 10 shows a similar region of very high Cu content. Also note that there is a relatively large globular region of Pb. These Pb-rich regions are larger than the Pb particles in the nut at locations remote from the surface (Fig. 7). Figure 10 shows that these Pb regions are made up of what appear to be small Pb particles intertwined with porosity. A strong Cr peak was also obtained from this region.

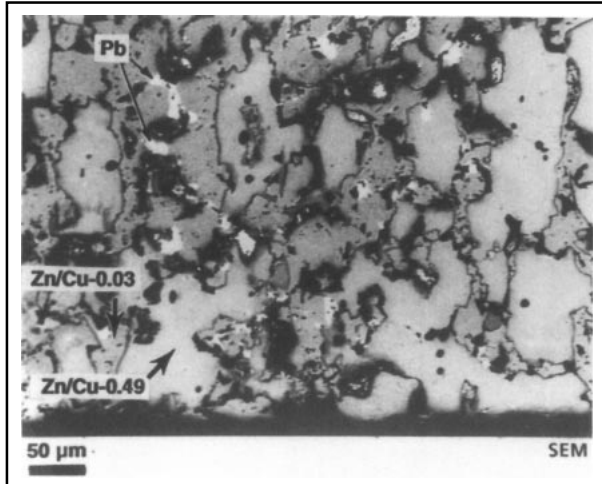
Fig. 9 Zinc-depleted region in the nut

Hummer (Ref 13) has reported the penetration rate of uniform dezincification of Naval brass when immersed in sea water to be about 20 μ m per year. Taking the life of the tug, 55 years, as the operating life of the valve, this predicts a corrosion depth of about 1000 μ m. Considering the lack of knowledge of the operating life and the corrosion environment of the valve, this value is in reasonable agreement with the typically observed penetration of about 200

μm (see Fig. 9). It appears that the valve had been in service many years.

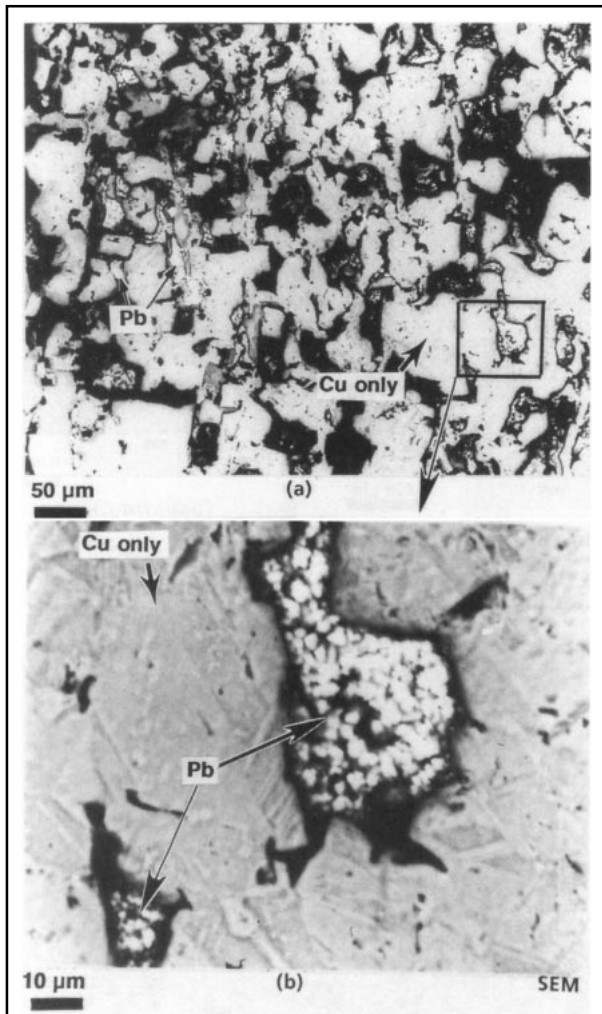
Fig. 10 Zinc-depleted region in the nut

In the Cu regions which remained, none or very little Zn was detected (Fig. 10-13). Also, these regions appeared Cu-colored when viewed with an optical microscope. The area in Fig. 12 noted "Cu" is an example of this. In many areas the β phase was clearly being attacked and replaced by Cu, as shown in Fig. 13. In others (Fig. 12) both phases were attacked. Associated with the Cu deposits was porosity, which is commonly found with dezincification (Ref 11, 12).

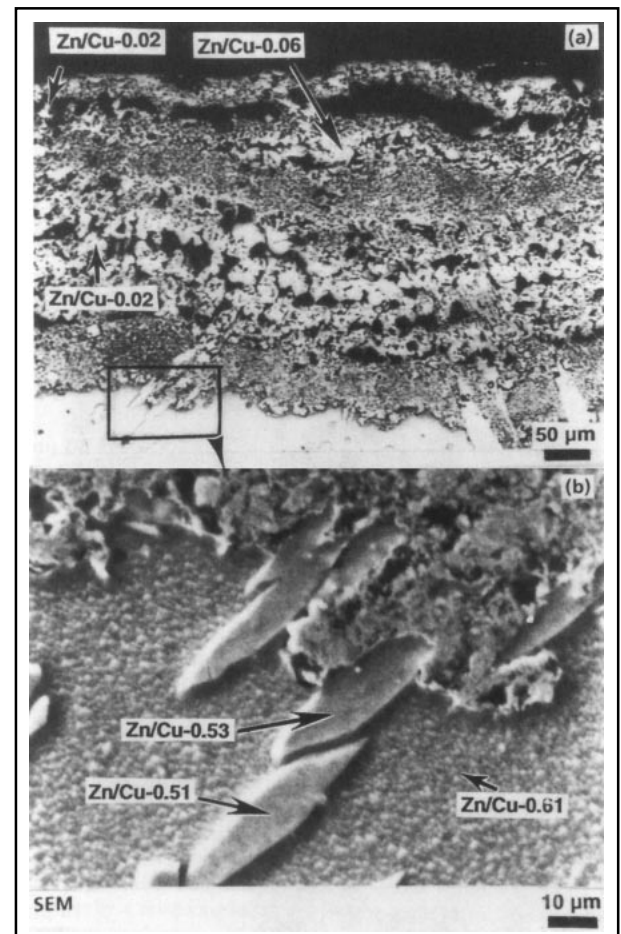
Figure 11 shows a Zn-depleted region of the welded tip. There is extensive porosity in this region. At the interface separating the unattacked region it is seen that both the α and the β phases are attacked. Figure 12 shows a region of the nut in which the higher copper content β phase is being selectively attacked.

Fig. 11 Zinc-depleted region in the welded tip of the valve seat

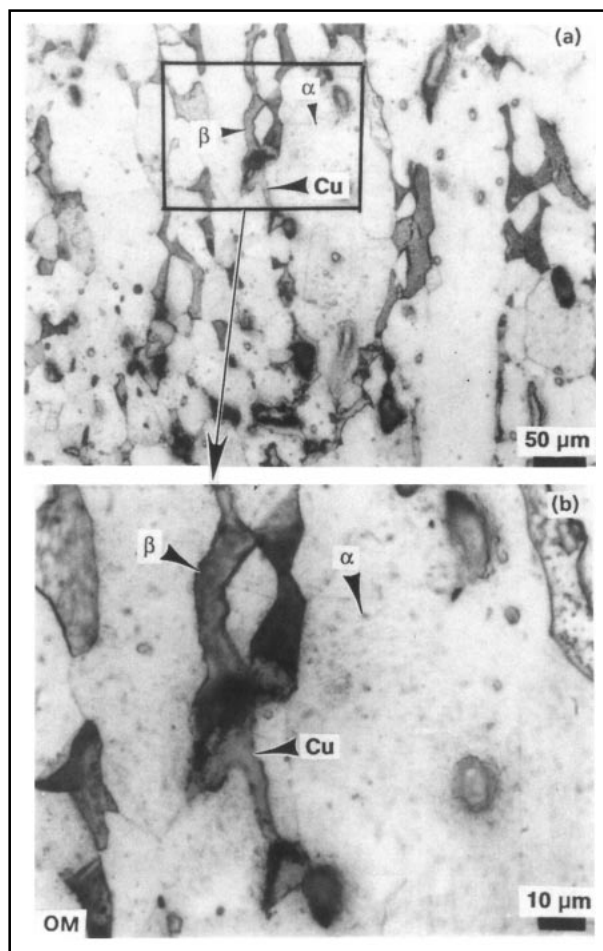
Fig. 12 Zinc-depleted region in the nut showing selective dezincification of the β phase
